Manhole Inspection Summary

Manhole # S43A2_023MH

Insp Date: **12/14/07 10:17 AM**

Location Address: **3710 West Bay Ave.**

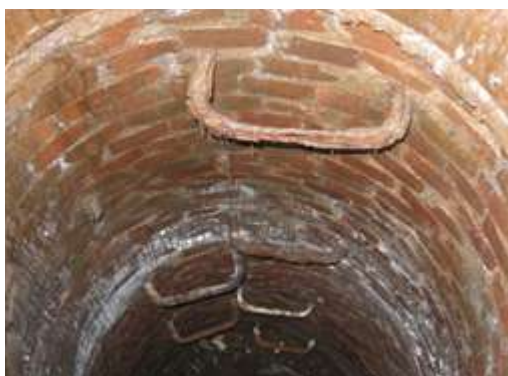
Steps

Count: **7** Missing: **1** ☒ Corroded

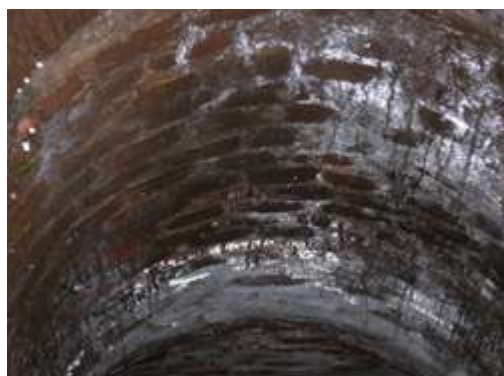
Defect 2

Infiltration: ☐ None ☐ Joint ☐ Cracks ☐ Mortar ☐ Roots ☒ Wall

Wall

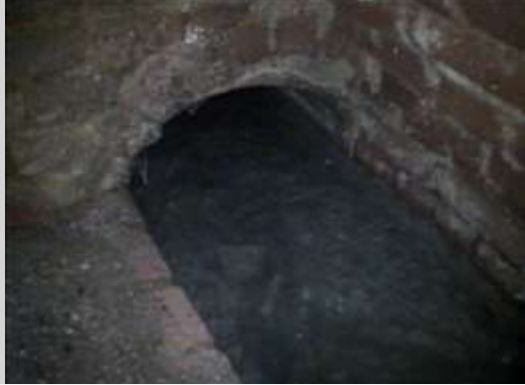
12 O'Clock Outflow

15 in. Circular Gravity Sewer
Pipe Out @ 12 O'Clock

Pipe Height: **12** (in.) Rod and Bar (Angled)
Pipe Material: **Clay** ☐ Pipe Lined
Invert Depth: **13.40** (ft.) Flow Characteristics: **Slow**
Deposits: ☒ None ☐ Mud ☐ Sludge ☐ Debris ☐ Grease
Silt Depth: (in.) Deposits Extent:
Infiltration: **None** Pipe Seal Cond: **Sound**

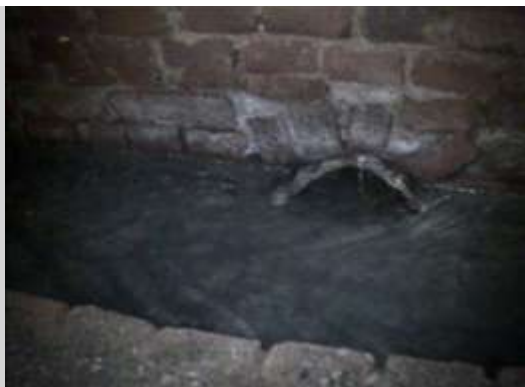
3 O'Clock Inflow

6 in. Circular Service Sewer
Pipe In @ 3 O'Clock

Pipe Height: **7.2** (in.) Rod and Bar (Angled)
Pipe Material: **Clay** ☐ Pipe Lined
Invert Depth: **13.36** (ft.) Flow Characteristics: **Slow**
Deposits: ☒ None ☐ Mud ☐ Sludge ☐ Debris ☐ Grease
Silt Depth: (in.) Deposits Extent:
Infiltration: **None** Pipe Seal Cond: **Sound**

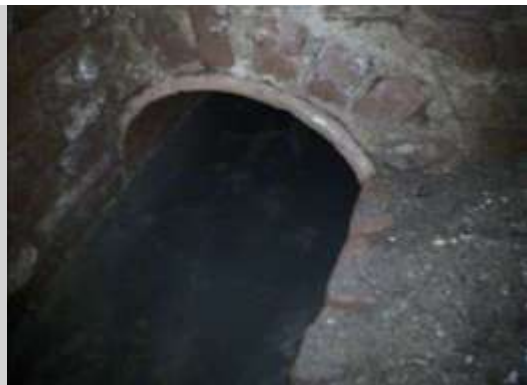
6 O'Clock Inflow

15 in. Circular Gravity Sewer
Pipe In @ 6 O'Clock

Pipe Height: **15.6** (in.) Rod and Bar (Angled)

Pipe Material: **Clay** ☐ Pipe Lined

Invert Depth: **13.53** (ft.) Flow Characteristics: **Slow**

Deposits: ☒ None ☐ Mud ☐ Sludge ☐ Debris ☐ Grease

Infiltration: **None** Pipe Seal Cond: **Sound**
